Test Report

Document number: (5093/830/14b) – Pan of 3 July 2014

Order contents: Testing of watertightness of intersections/tie points provided with water-swellable sealing rings/plugs, in concrete building structures with high resistance to water penetration

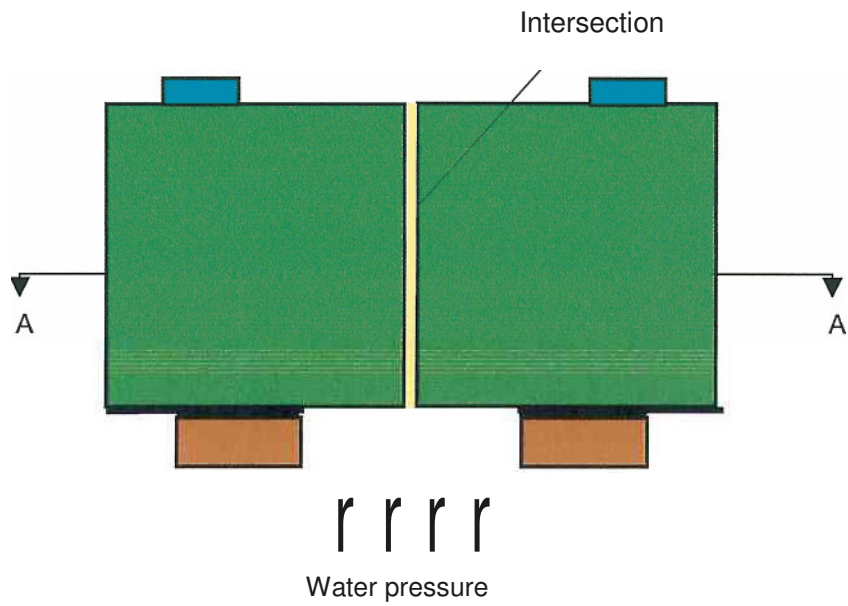
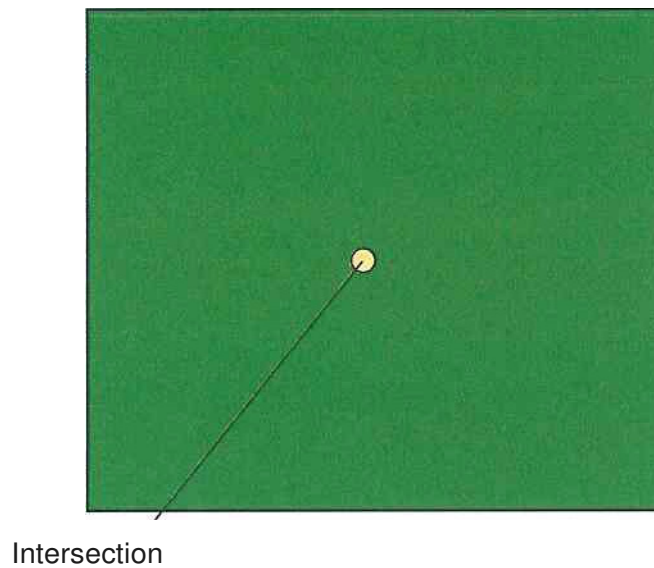
Section A-A

Picture A1: schematic diagram: water tightness test (concrete slabs 20 x 20 x 10 cm³)

The connecting surfaces were tested for watertightness on the intersections encased in concrete slabs (waterproof concrete, dimensions: 20 cm x 20 cm x 10 cm, compressive strength class 30/37) according to DIN 1048-5 (picture A 1). The intersections were wrapped with film down to the sealed area before encasing these in concrete in order to assure reliable access of the water to the areas provided with sealing rings and to assure the discharge of the water in case of a leak. After 28 days of curing time the samples were installed in a water penetration tester and water pressure applied step by step from 0.5 bar to 5.0 bar with residence times of 48 hours and kept at a constant level for 7 days. The following Table shows the test results.

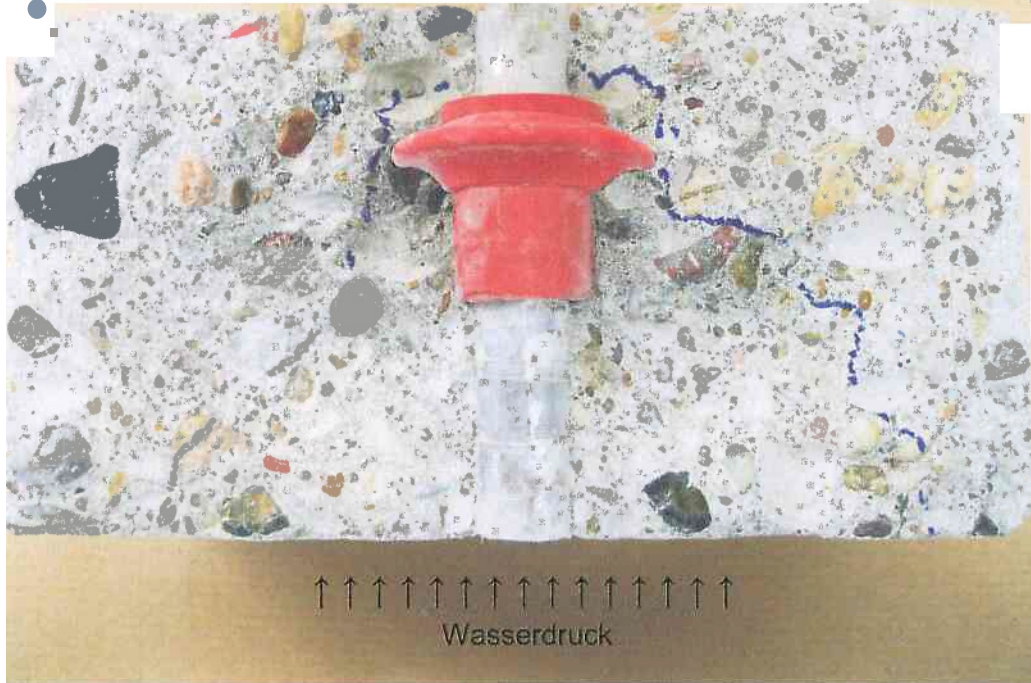
Picture A2: sample 1: tie rod (ripped steel $\varnothing = 16$ mm)

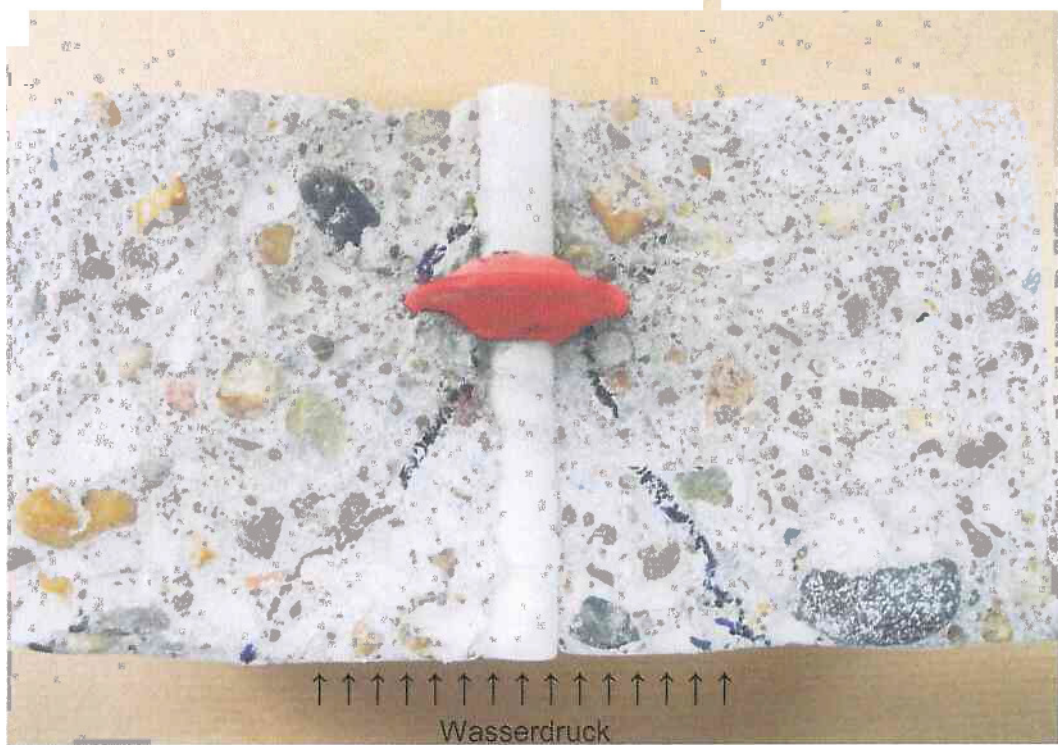
Picture A3: sample 2: glass fiber rod (ripped $\varnothing = 14$ mm)

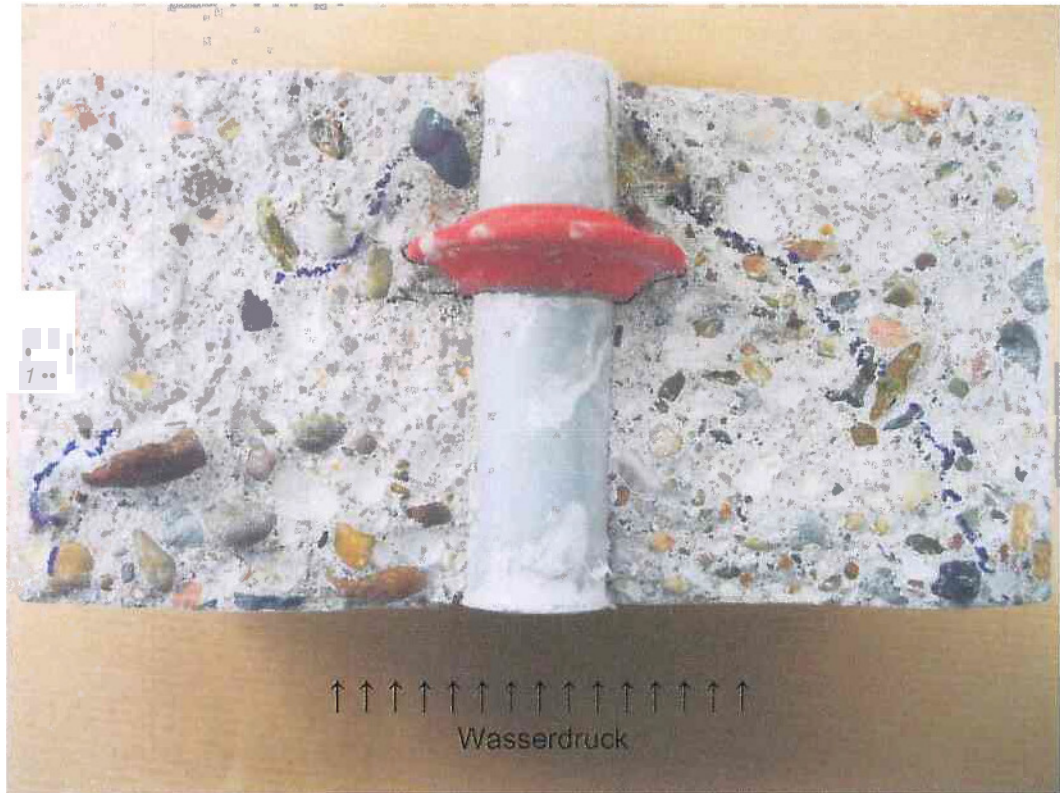
Picture A4: sample 3: plastic pipe (inner $\varnothing = 22$ mm, outer $\varnothing = 26$ mm)

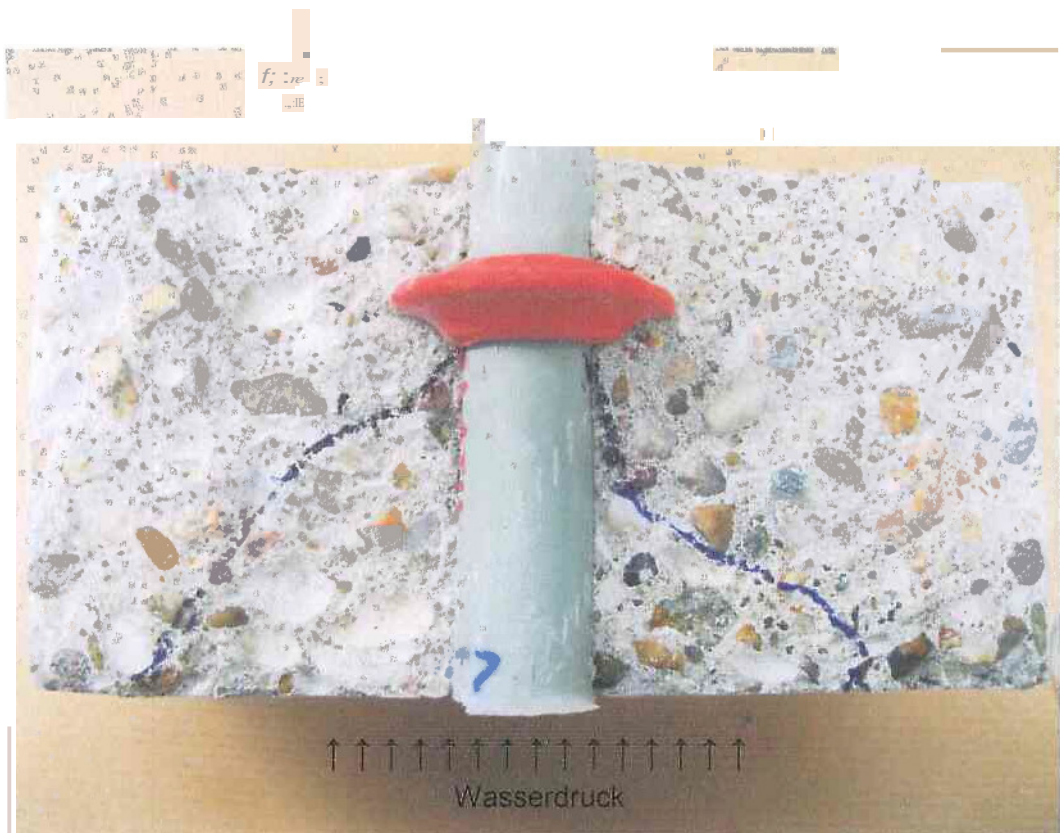
Picture A5: sample 4: plastic pipe (inner $\varnothing = 22$ mm, outer $\varnothing = 26$ mm); negative water pressure on plug
